# **GROUNDING TEST POSTS FOR PHOTOVOLTAIC PANEL FRAMES**

**Keystone Site  
1067 Lancaster Pike  
Quarryville, Pennsylvania 17566  
February 8, 2012  
Project No. SRP20120035**

**RE: Geotechnical Investigation Report  
Grounded Posts for Photovoltaic Panel Frames  
Keystone Site  
1067 Lancaster Pike  
Quarryville, Lancaster County, Pennsylvania 17566  
Schletter Project No. SRP20120035**

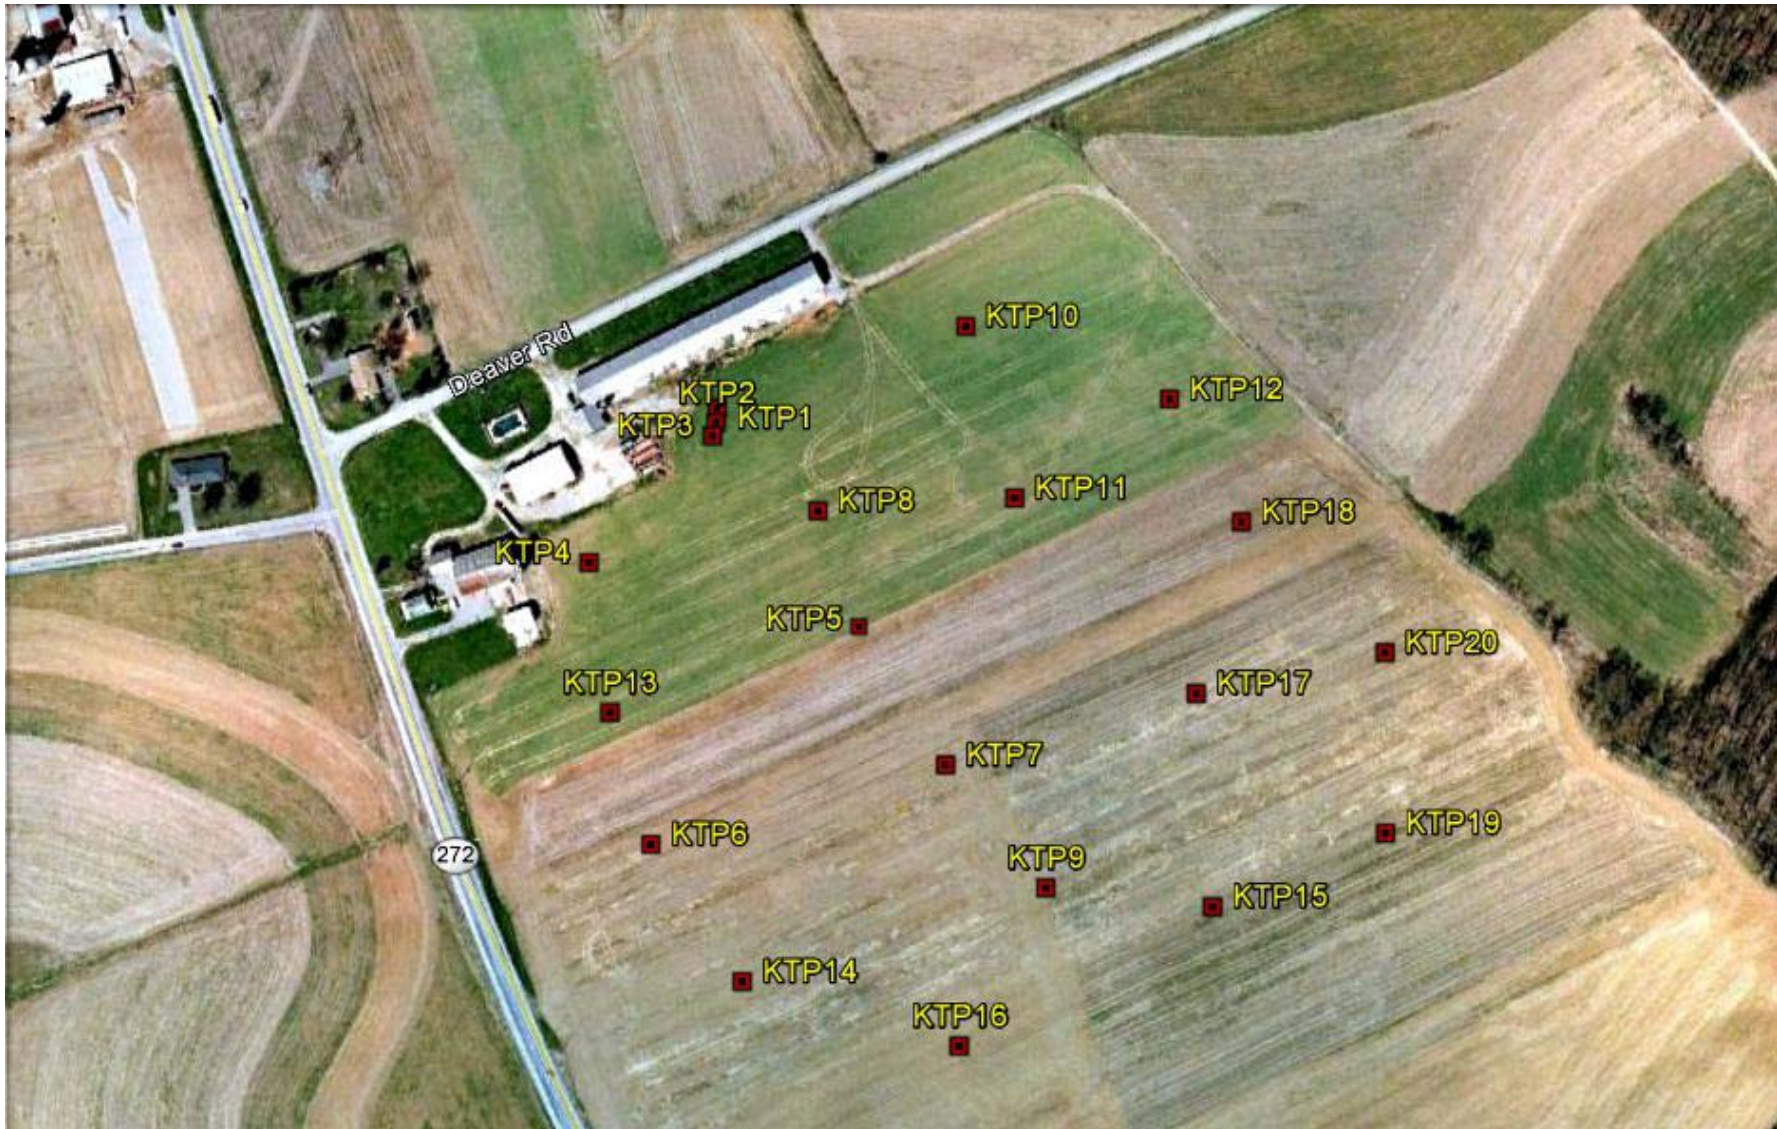
SITE PLAN

Twenty (20) test posts of size FG7 were advanced by Schletter January 18 - 19, 2012 using a rubber tracked GAYK HRE 4000 hydraulic hammer rig. Test Post 1 (KTP1) and Test Post 2 (KTP2), were advanced to a depth of 6.0 ft (72.0 inches) bgs and 7.0 ft (84.0 inches) bgs, respectively. Test Post 3 (KTP3) – Test Post 20 (KTP20) were all advanced to a depth of 8.0 ft bgs. All twenty (20) test post locations are shown on a general Site plan in Appendix A.

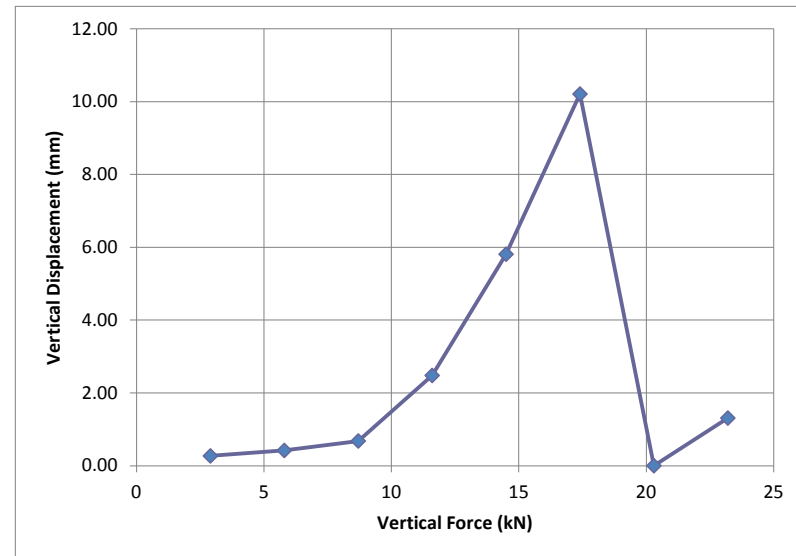
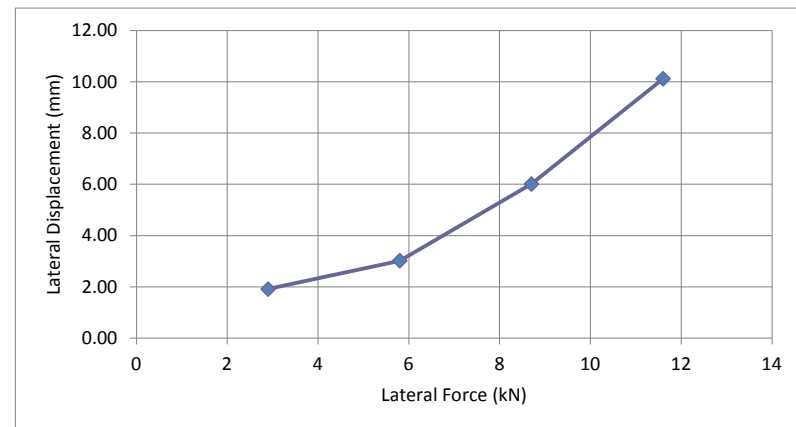
<b>Pile No.</b>	<b>KTP1</b>
-----------------	-------------

Vertical Pressure (bar)	Vertical Force (kN)	Vertical Displacement (mm)
20	2.9	0.27
40	5.8	0.42
60	8.7	0.68
80	11.6	2.48
100	14.5	5.81
120	17.4	10.21
140	20.3	<b>24.78; Test Failed</b>
160	23.2	1.31
180	26.1	2.81
200	29.0

Lateral Pressure (bar)	Lateral Force (kN)	Lateral Displacement (mm)
20	2.9	1.91
40	5.8	3.02
60	8.7	6.01
80	11.6	10.12
100	14.5	13.18

Height of Caliper (mm)	Height of Jack (mm)	Embedment Depth (mm)
88.9	660.4	1828.6

KTP1 was embedded to 6.0 ft (72.0 inches) depth, deflected 24.78 millimeters at the maximum test load which exceeds the allowable deformation of 19.05 millimeters of movement for the vertical pull-out capacity test, and subsequently failed the test. The lateral deformation was measured to be 13.18 millimeters at the maximum test load which is less than the allowable deflection.

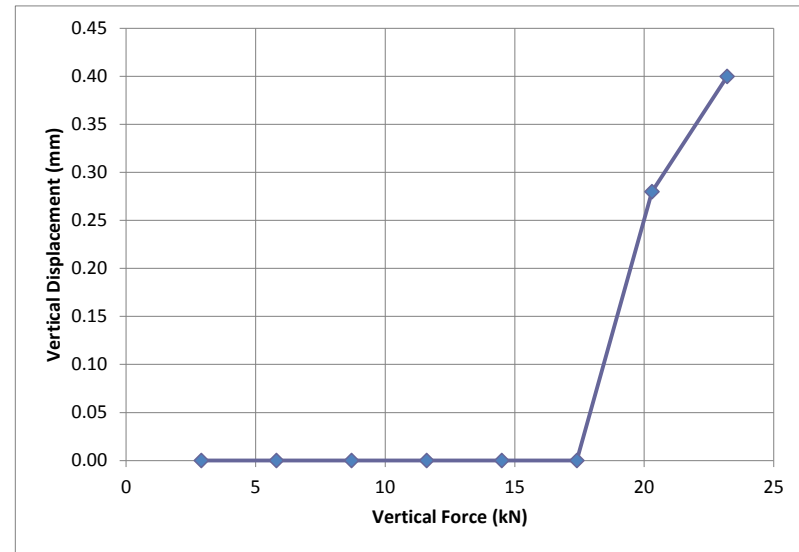
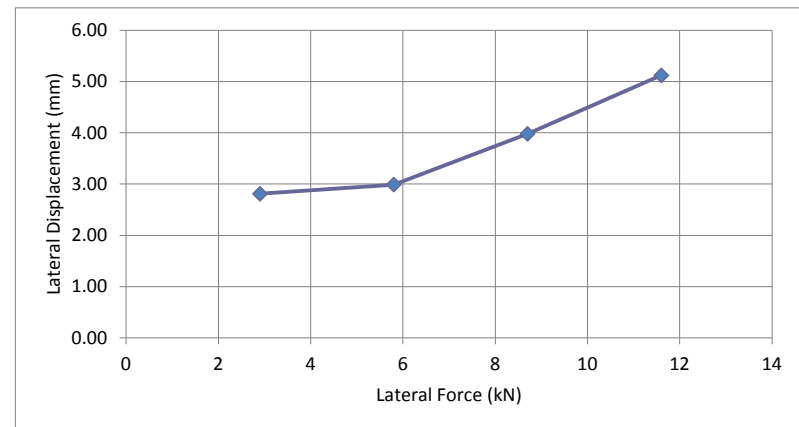
<b>Pile No.</b>	<b>KTP4</b>
-----------------	-------------

Vertical Pressure (bar)	Vertical Force (kN)	Vertical Displacement (mm)
20	2.9	0.00
40	5.8	0.00
60	8.7	0.00
80	11.6	0.00
100	14.5	0.00
120	17.4	0.00
140	20.3	0.28
160	23.2	0.40
180	26.1	1.09
200	29.0	1.13

Lateral Pressure (bar)	Lateral Force (kN)	Lateral Displacement (mm)
20	2.9	2.81
40	5.8	2.99
60	8.7	3.98
80	11.6	5.12
100	14.5	6.89

Height of Caliper (mm)	Height of Jack (mm)	Embedment Depth (mm)
120.6	622.3	2438.4

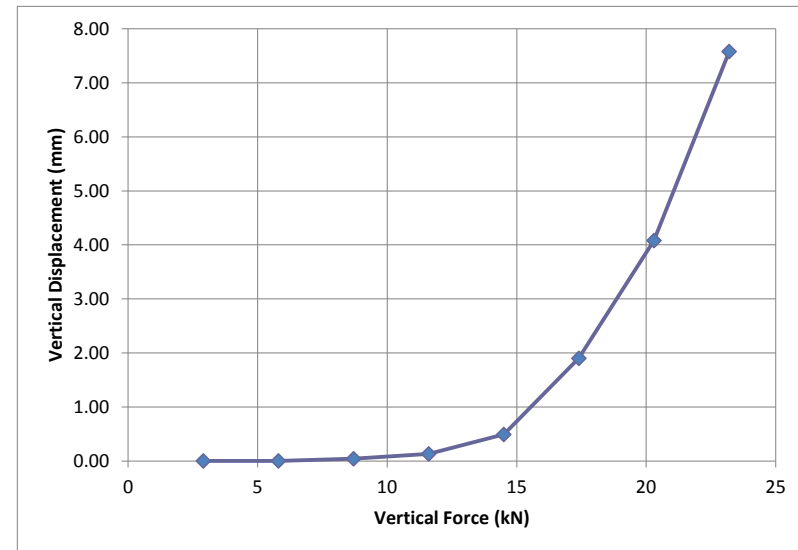
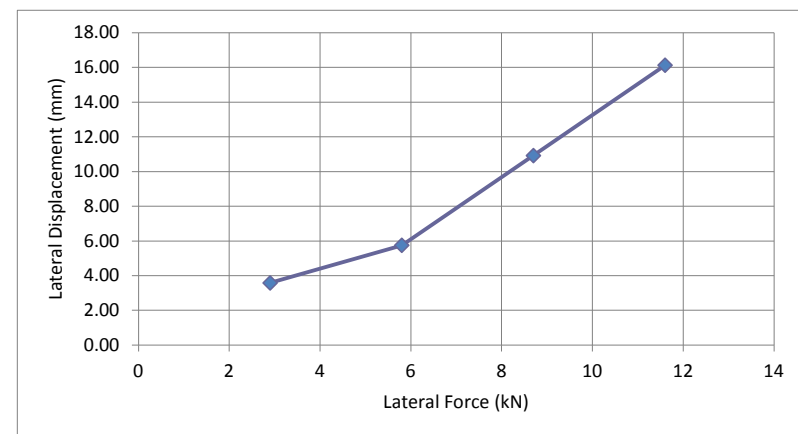
<b>Pile No.</b>	<b>KTP5</b>
-----------------	-------------

Vertical Pressure (bar)	Vertical Force (kN)	Vertical Displacement (mm)
20	2.9	0.00
40	5.8	0.00
60	8.7	0.04
80	11.6	0.13
100	14.5	0.49
120	17.4	1.90
140	20.3	4.08
160	23.2	7.58
180	26.1	9.39
200	29.0	11.95

Lateral Pressure (bar)	Lateral Force (kN)	Lateral Displacement (mm)
20	2.9	3.58
40	5.8	5.75
60	8.7	10.92
80	11.6	16.13
100	14.5	<b>21.55; Test Failed</b>

Height of Caliper (mm)	Height of Jack (mm)	Embedment Depth (mm)
88.9	622.3	2438.4

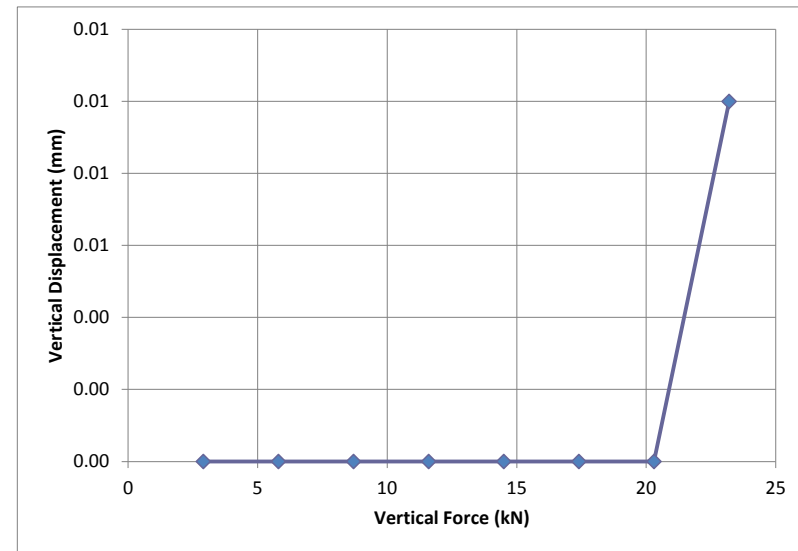
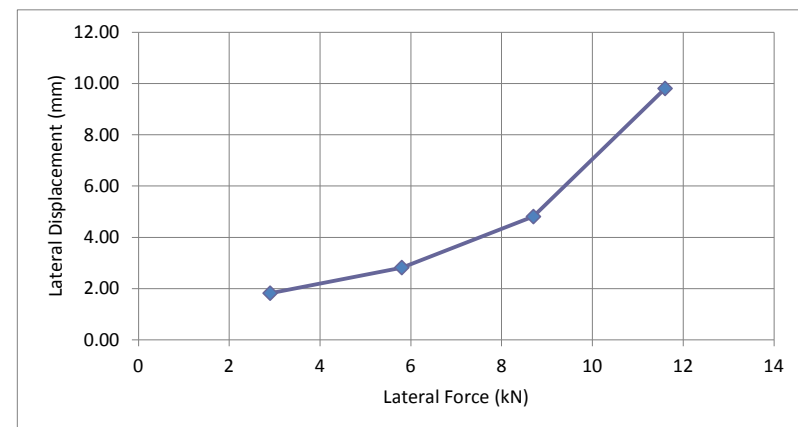
<b>Pile No.</b>	<b>KTP6</b>
-----------------	-------------

Vertical Pressure (bar)	Vertical Force (kN)	Vertical Displacement (mm)
20	2.9	0.00
40	5.8	0.00
60	8.7	0.00
80	11.6	0.00
100	14.5	0.00
120	17.4	0.00
140	20.3	0.00
160	23.2	0.01
180	26.1	0.02
200	29.0	0.06

Lateral Pressure (bar)	Lateral Force (kN)	Lateral Displacement (mm)
20	2.9	1.82
40	5.8	2.82
60	8.7	4.81
80	11.6	9.81
100	14.5	15.82

Height of Caliper (mm)	Height of Jack (mm)	Embedment Depth (mm)
101.6	698.5	2438.4

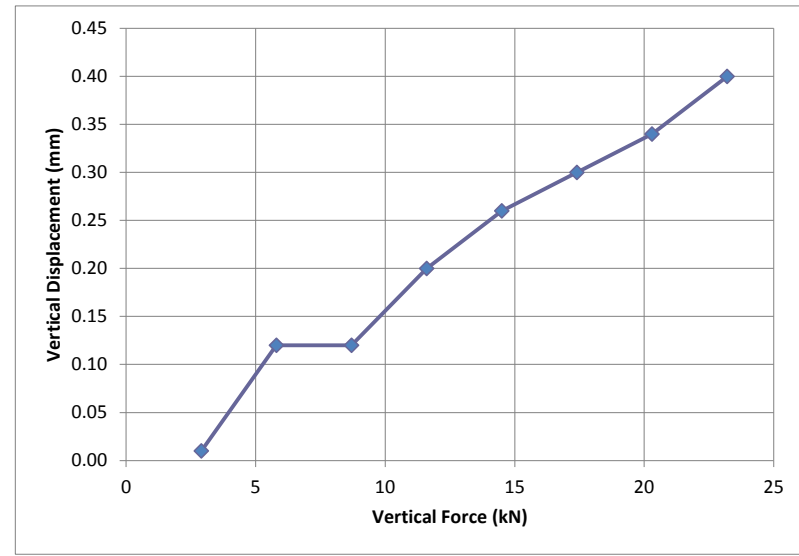
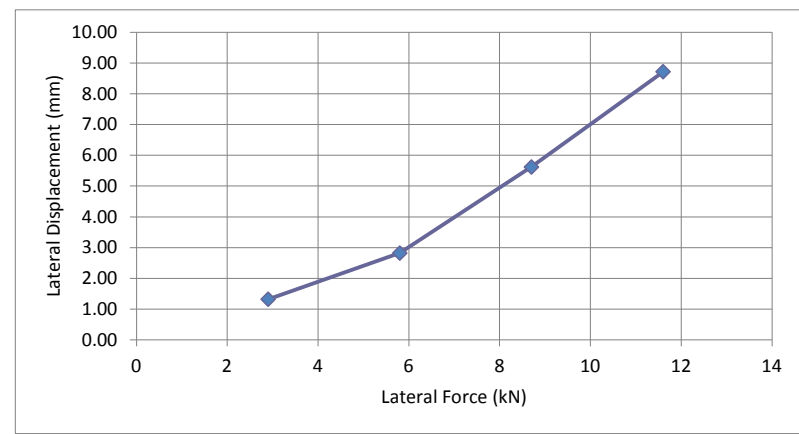
<b>Pile No.</b>	<b>KTP7</b>
-----------------	-------------

Vertical Pressure (bar)	Vertical Force (kN)	Vertical Displacement (mm)
20	2.9	0.01
40	5.8	0.12
60	8.7	0.12
80	11.6	0.20
100	14.5	0.26
120	17.4	0.30
140	20.3	0.34
160	23.2	0.40
180	26.1	0.49
200	29.0	0.54

Lateral Pressure (bar)	Lateral Force (kN)	Lateral Displacement (mm)
20	2.9	1.32
40	5.8	2.82
60	8.7	5.62
80	11.6	8.72
100	14.5	11.21

Height of Caliper (mm)	Height of Jack (mm)	Embedment Depth (mm)
114.3	584.2	2438.4

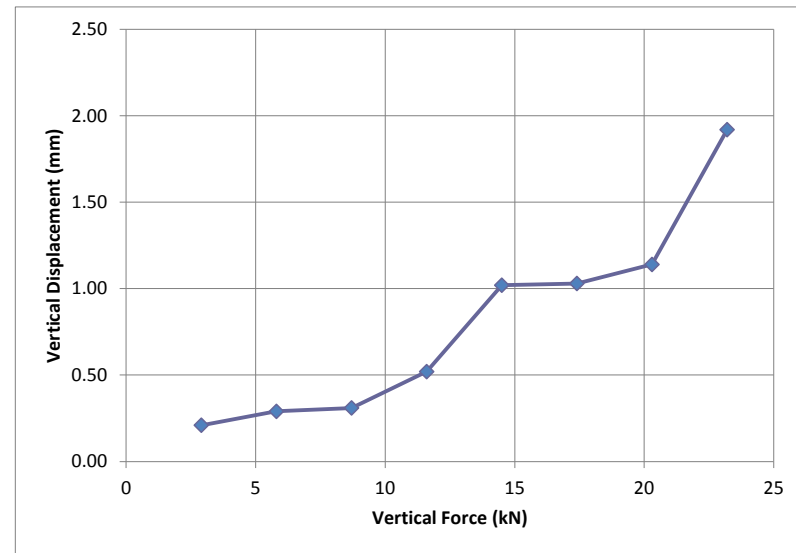
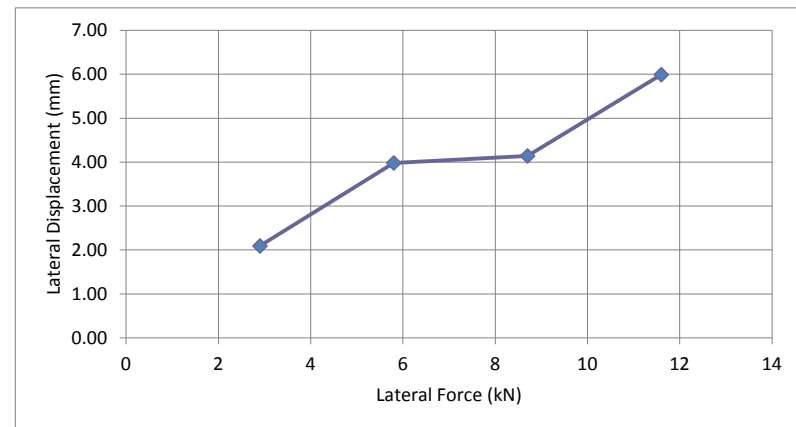
<b>Pile No.</b>	<b>KTP11</b>
-----------------	--------------

Vertical Pressure (bar)	Vertical Force (kN)	Vertical Displacement (mm)
20	2.9	0.21
40	5.8	0.29
60	8.7	0.31
80	11.6	0.52
100	14.5	1.02
120	17.4	1.03
140	20.3	1.14
160	23.2	1.92
180	26.1	1.99
200	29.0	1.99

Lateral Pressure (bar)	Lateral Force (kN)	Lateral Displacement (mm)
20	2.9	2.09
40	5.8	3.98
60	8.7	4.14
80	11.6	5.99
100	14.5	8.12

Height of Caliper (mm)	Height of Jack (mm)	Embedment Depth (mm)
88.9	698.5	2438.4

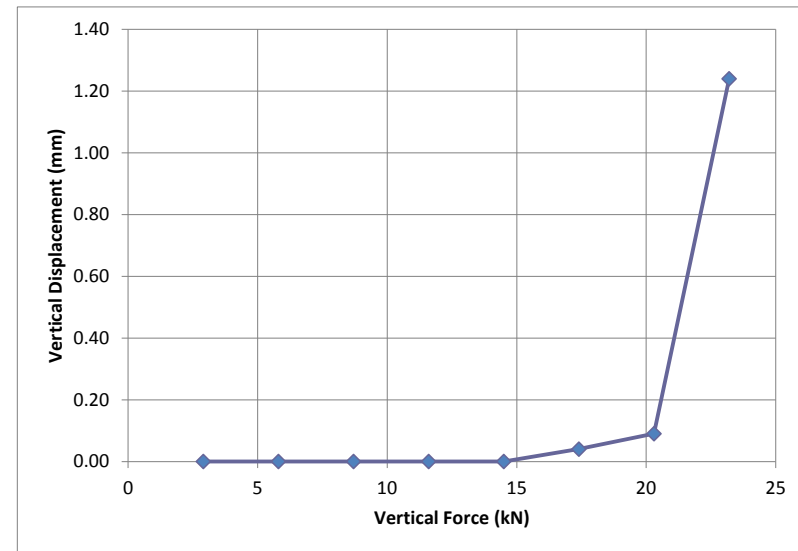
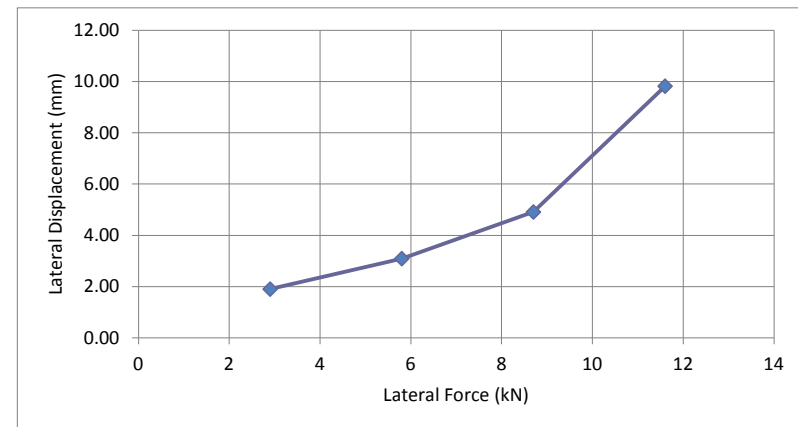
<b>Pile No.</b>	<b>KTP13</b>
-----------------	--------------

Vertical Pressure (bar)	Vertical Force (kN)	Vertical Displacement (mm)
20	2.9	0.00
40	5.8	0.00
60	8.7	0.00
80	11.6	0.00
100	14.5	0.00
120	17.4	0.04
140	20.3	0.09
160	23.2	1.24
180	26.1	2.01
200	29.0	2.52

Lateral Pressure (bar)	Lateral Force (kN)	Lateral Displacement (mm)
20	2.9	1.90
40	5.8	3.09
60	8.7	4.91
80	11.6	9.82
100	14.5	14.01

Height of Caliper (mm)	Height of Jack (mm)	Embedment Depth (mm)
107.9	565.2	2438.4

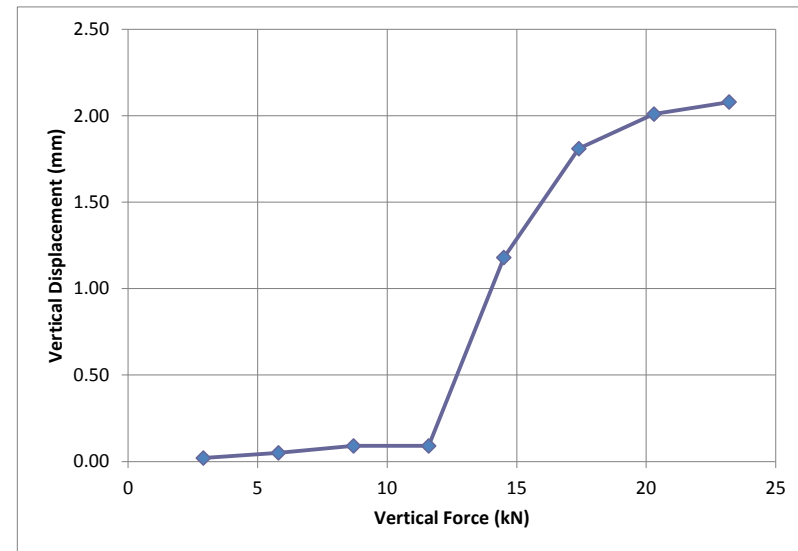
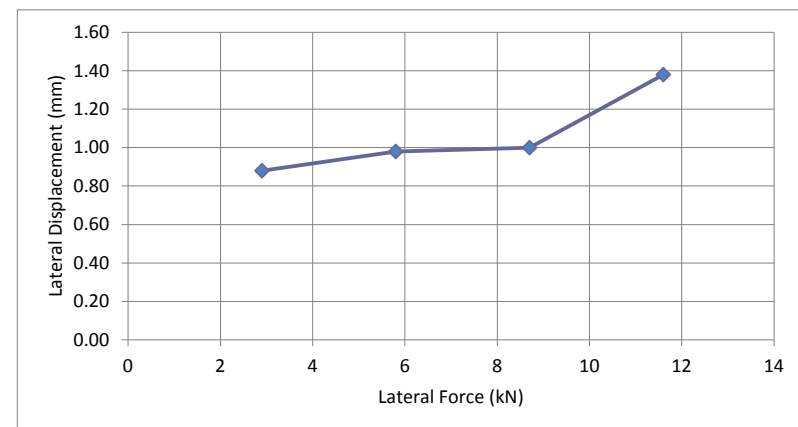
<b>Pile No.</b>	<b>KTP14</b>
-----------------	--------------

Vertical Pressure (bar)	Vertical Force (kN)	Vertical Displacement (mm)
20	2.9	0.02
40	5.8	0.05
60	8.7	0.09
80	11.6	0.09
100	14.5	1.18
120	17.4	1.81
140	20.3	2.01
160	23.2	2.08
180	26.1	2.18
200	29.0	2.38

Lateral Pressure (bar)	Lateral Force (kN)	Lateral Displacement (mm)
20	2.9	0.88
40	5.8	0.98
60	8.7	1.00
80	11.6	1.38
100	14.5	1.48

Height of Caliper (mm)	Height of Jack (mm)	Embedment Depth (mm)
95.3	622.3	2438.4

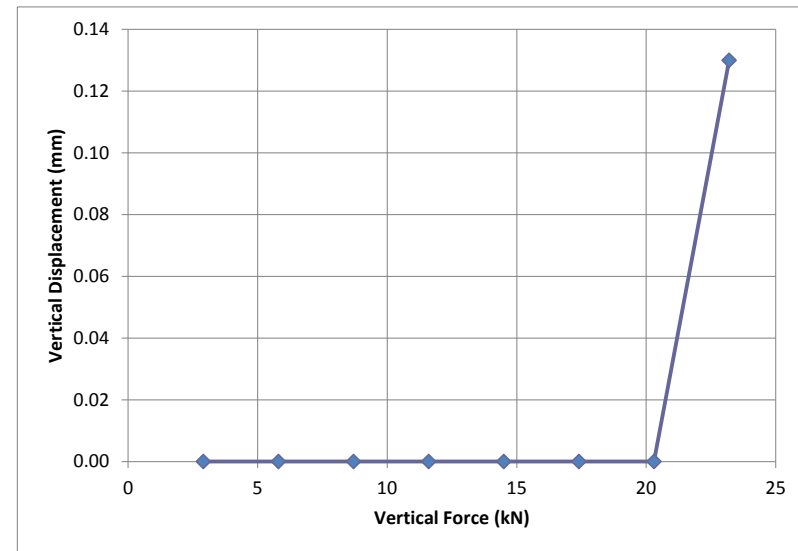
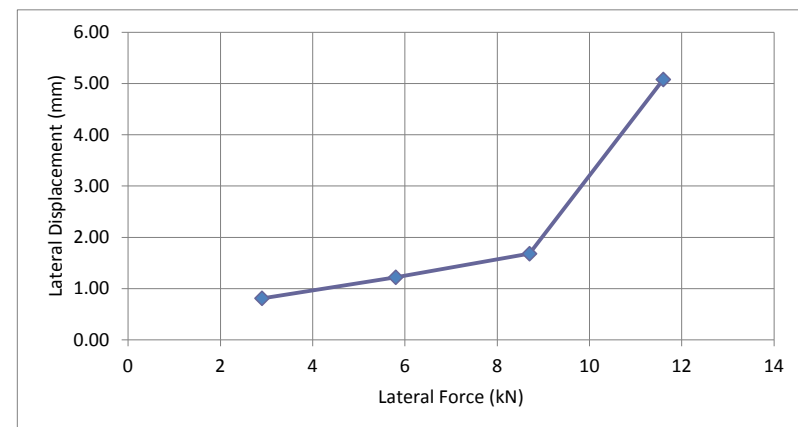
<b>Pile No.</b>	<b>KTP18</b>
-----------------	--------------

Vertical Pressure (bar)	Vertical Force (kN)	Vertical Displacement (mm)
20	2.9	0.00
40	5.8	0.00
60	8.7	0.00
80	11.6	0.00
100	14.5	0.00
120	17.4	0.00
140	20.3	0.00
160	23.2	0.13
180	26.1	0.13
200	29.0	0.19

Lateral Pressure (bar)	Lateral Force (kN)	Lateral Displacement (mm)
20	2.9	0.81
40	5.8	1.22
60	8.7	1.68
80	11.6	5.08
100	14.5	6.99

Height of Caliper (mm)	Height of Jack (mm)	Embedment Depth (mm)
107.9	666.7	2438.4

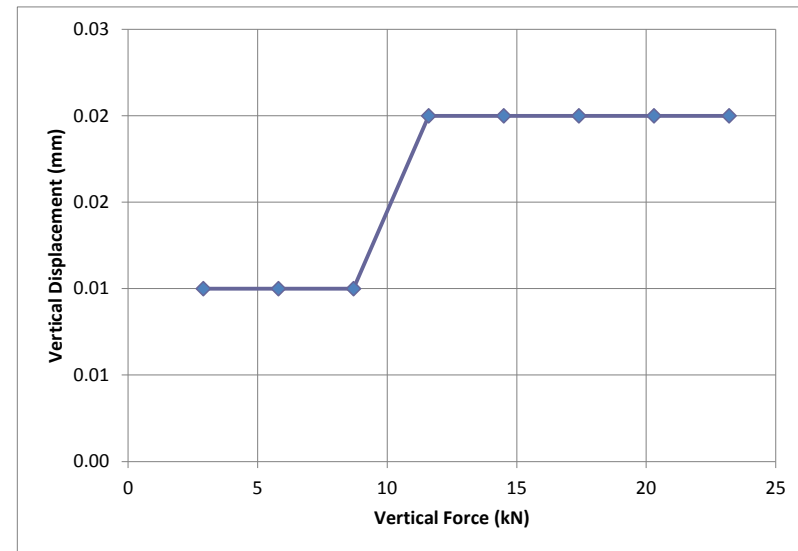
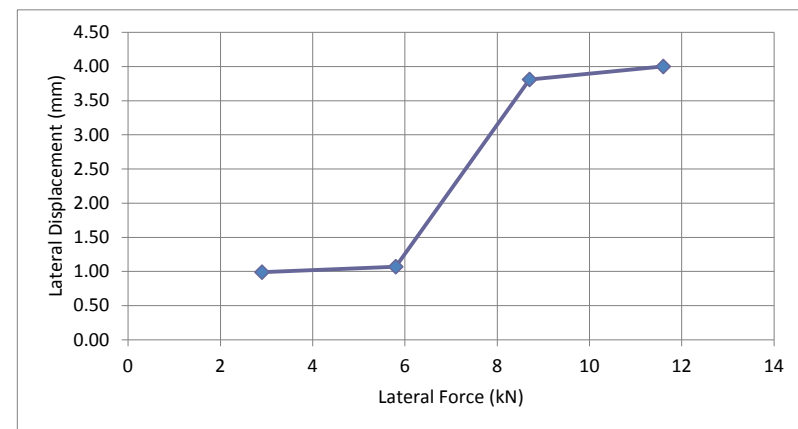
<b>Pile No.</b>	<b>KTP19</b>
-----------------	--------------

Vertical Pressure (bar)	Vertical Force (kN)	Vertical Displacement (mm)
20	2.9	0.01
40	5.8	0.01
60	8.7	0.01
80	11.6	0.02
100	14.5	0.02
120	17.4	0.02
140	20.3	0.02
160	23.2	0.02
180	26.1	0.05
200	29.0	0.06

Lateral Pressure (bar)	Lateral Force (kN)	Lateral Displacement (mm)
20	2.9	0.99
40	5.8	1.07
60	8.7	3.81
80	11.6	4.00
100	14.5	9.82

Height of Caliper (mm)	Height of Jack (mm)	Embedment Depth (mm)
127.0	596.9	2438.4

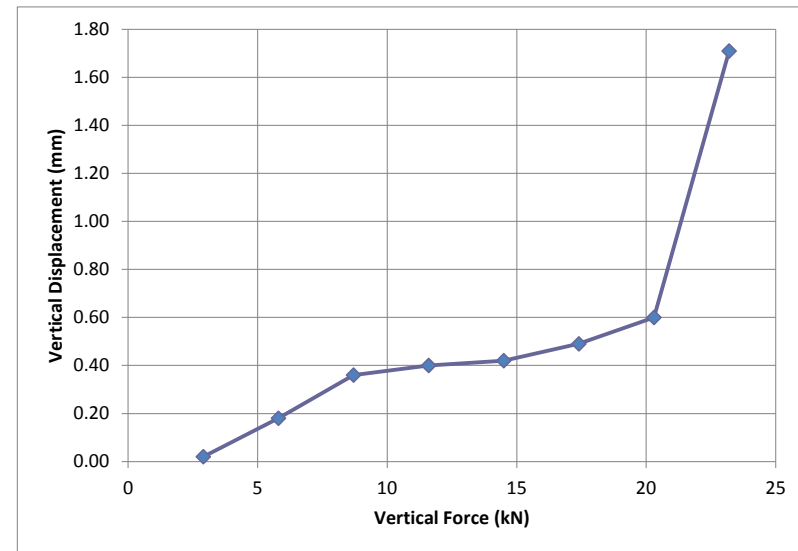
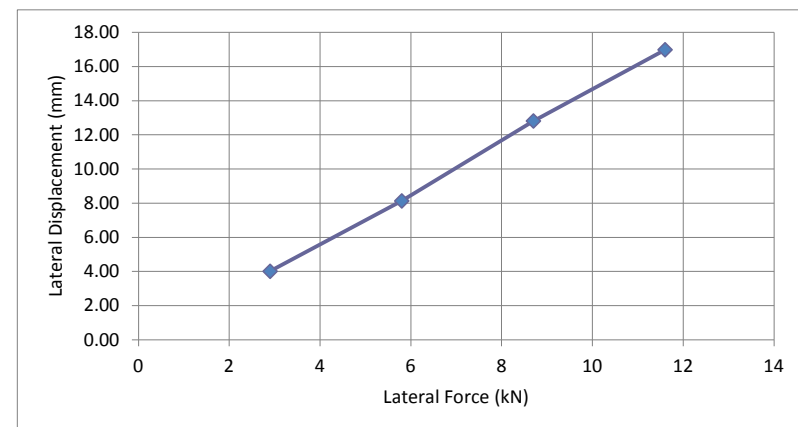
<b>Pile No.</b>	<b>KTP20</b>
-----------------	--------------

Vertical Pressure (bar)	Vertical Force (kN)	Vertical Displacement (mm)
20	2.9	0.02
40	5.8	0.18
60	8.7	0.36
80	11.6	0.40
100	14.5	0.42
120	17.4	0.49
140	20.3	0.60
160	23.2	1.71
180	26.1	2.01
200	29.0	2.99

Lateral Pressure (bar)	Lateral Force (kN)	Lateral Displacement (mm)
20	2.9	4.01
40	5.8	8.13
60	8.7	12.81
80	11.6	16.98
100	14.5	17.82

Height of Caliper (mm)	Height of Jack (mm)	Embedment Depth (mm)
101.6	622.3	2438.4

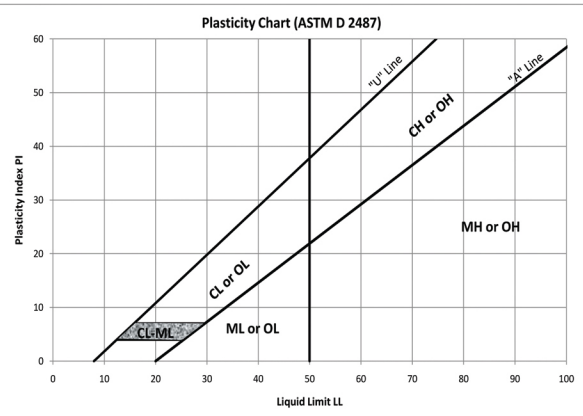
INORGANIC	PI >4 AND PLOTS <"A" LINE	ML	SILT	
		ORGANIC	LL (oven dried)/LL (not dried) <0.75	OL	ORGANIC CLAY OR SILT	
	SILTS AND CLAYS  LIQUID LIMIT >50	INORGANIC	PI PLOTS >"A" LINE	CH	FAT CLAY	
		INORGANIC	PI PLOTS <"A" LINE	MH	ELASTIC SILT	
		ORGANIC	LL (oven dried)/LL (not dried) <0.75	OH	ORGANIC CLAY OR SILT	
HIGHLY ORGANIC SOILS		PRIMARILY ORGANIC MATTER, DARK IN COLOR, AND ORGANIC ODOR		PT	PEAT

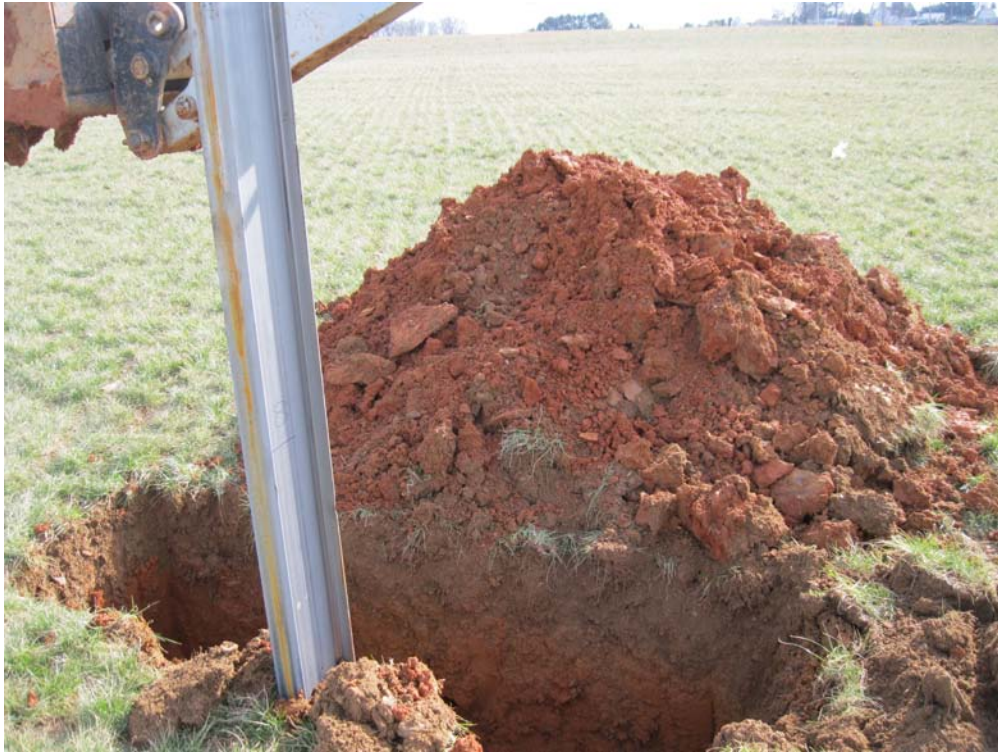
View of KTP18 excavation pit and soils pile.

The observed soil profiles of KTP6, KTP7, KTP17, KTP18 and KTP20 encountered approximately 0.4/1.0 ft black brown Organic Topsoil, underlain by approximately 2.0 ft Sandy lean CLAY with fine gravel, underlain 3.5 ft orange brown Sandy SILT w/fine Gravel, followed by approximately 1.5 ft orange brown fine Sandy CLAY w/fine Gravel, trace rock pinnacles and trace mica.

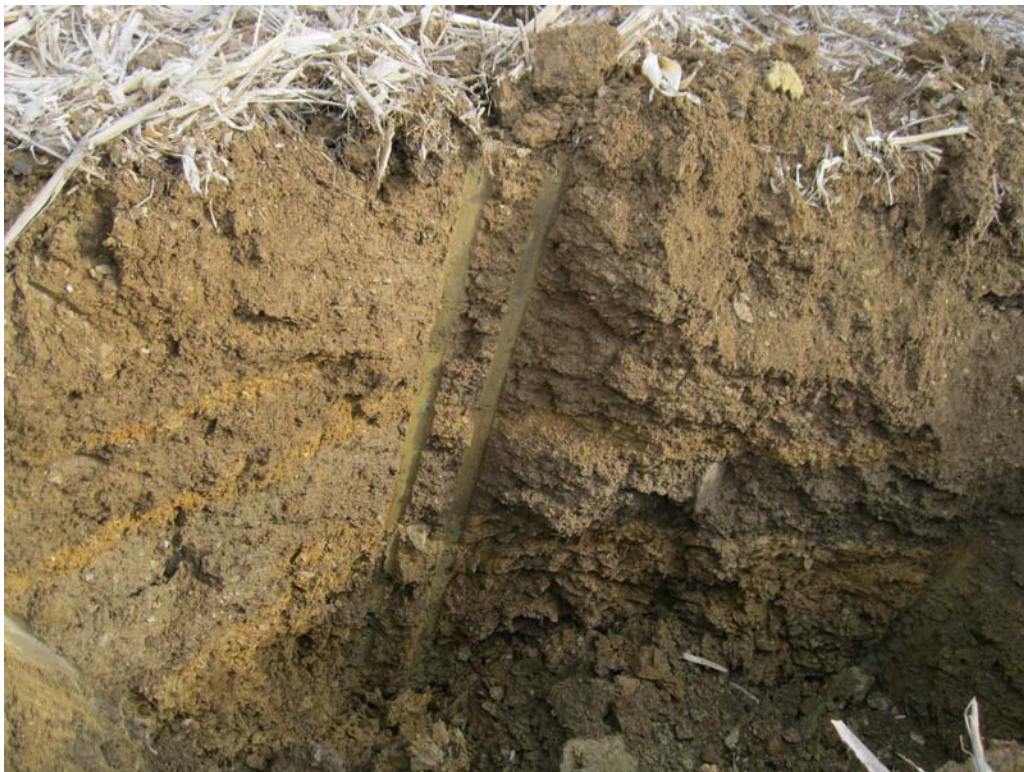
View of KTP8 subsurface soils.

The observed soil profiles of KTP1, KTP2, KTP3, KTP4, KTP8 and KTP10 encountered approximately 0.4/1.0 ft black brown Organic Topsoil, underlain by approximately 2.0 ft orange brown Sandy lean CLAY, followed by approximately 5.0 ft orange brown Sandy SILT, trace rock pinnacles and some mica.
